Assessment and Inventory of Hydromodified Bank Structures in the Skagit River and Floodplain

**Final report submitted to the
Skagit Watershed Council
April 22, 2010**

**Prepared by
The Upper Skagit Indian Tribe
Natural Resources Division**

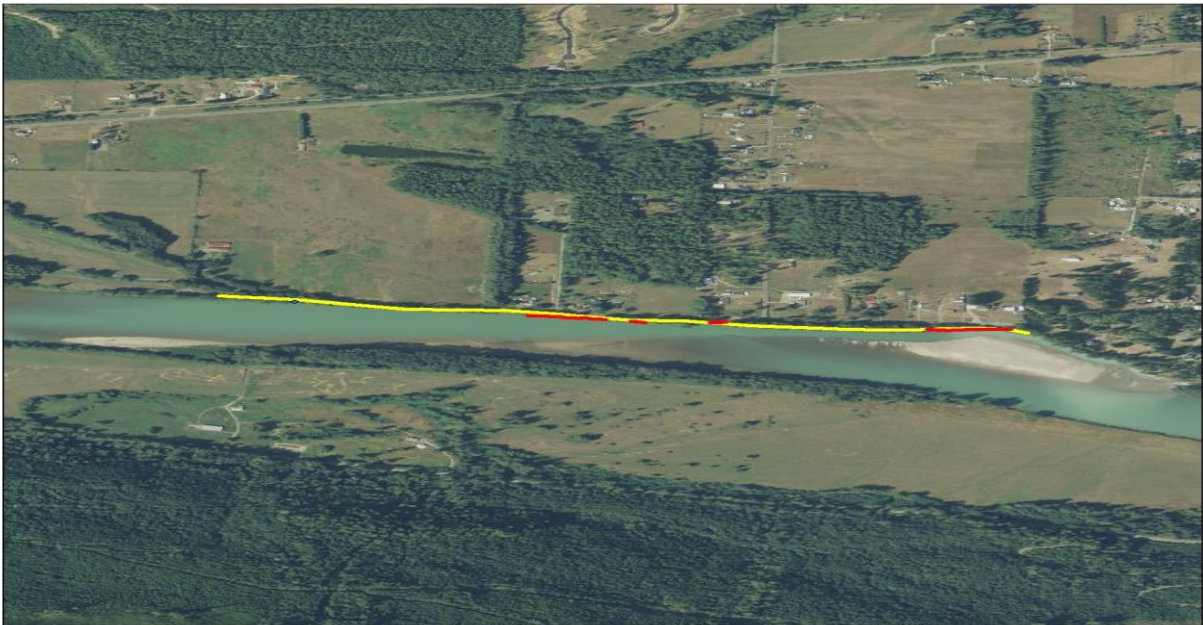
in the two data sets. See the picture below in reach SK070A with the yellow line representing old 1998 data and the red line depicting 2010 data.

The 1998 data identifies two hydromodified structures (Sk060B-11, and Sk070A-1) totaling 4024 feet, yet the comments state that areas are interspersed with bedrock. The 2010 data identified 4 structures (Sk070A-1, Sk070A-2, Sk070A-3, and Sk070A-4) totaling 909 feet. There is a road running parallel to the river above this entire stretch. The 2010 survey only delineated rip rap where it could be seen from the water's edge and did not map the road bed or any of the natural bedrock. The attached photograph below shows a clear break in hydromodified bank rock and natural bedrock, this picture was taken well within the yellow line and upstream portion of Sk070A-4. The largest difference in the two data sets is exemplified in this example, if a road was adjacent to a channel but no visual rock could be seen the road was not mapped and inventoried. In this example natural bedrock is a buffer from any potential geomorphic impacts to the river; surveyors did not see any placed rock therefore the feature was not mapped.
