# Technical Memorandum

**Date:** November 22, 2022

**Subject:** Geomorphic Mapping and Channel Migration Evaluation for the Sauk River Habitat Plan

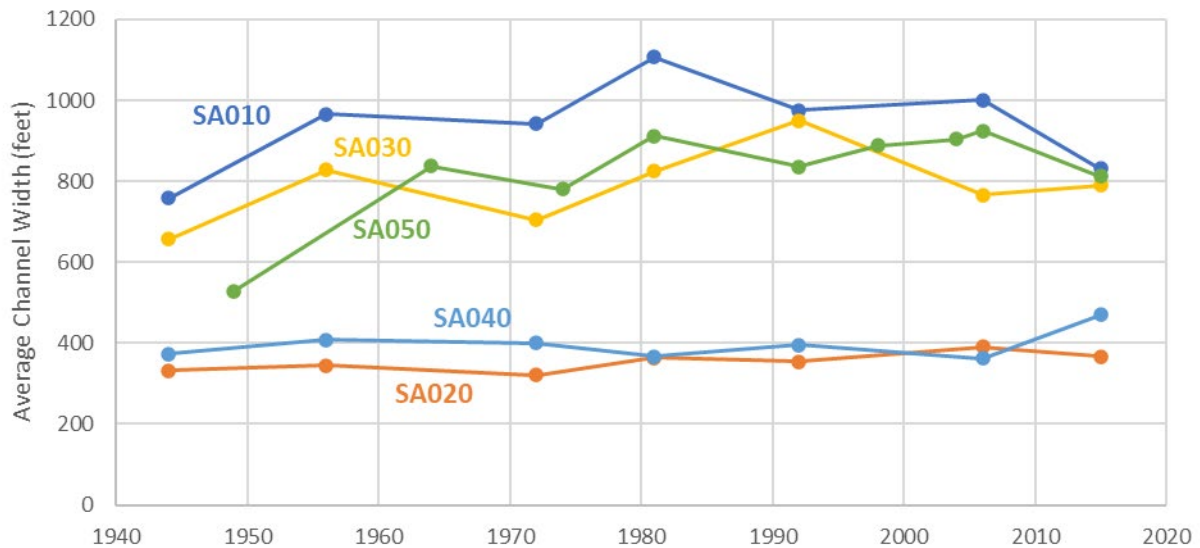
**Figure 4. Time series of average channel width, by reach.**

Measurements of active channel width reveal reach scale trends toward channel widening over the study period (Figure 4). The three unconfined channel reaches all expanded in width rapidly between the 1940s and subsequent imagery collected in the 1950s and 1960s. Channel width also increased rapidly in the period 1972-1981 (likely due to large flood in December 1980). Reach SA010 has since decreased in width from the maximum in 1981 to yield a net increase of 10% during the period 1944-2015. Reach SA030 continued to widen between 1981 and 1992 and then decreased slightly to yield a net 20% increase in channel width between 1944 and 2015. Reach SA050 was the most sensitive to changes in channel width showing a net 54% increase between 1949 and 2015 (Figure 4).

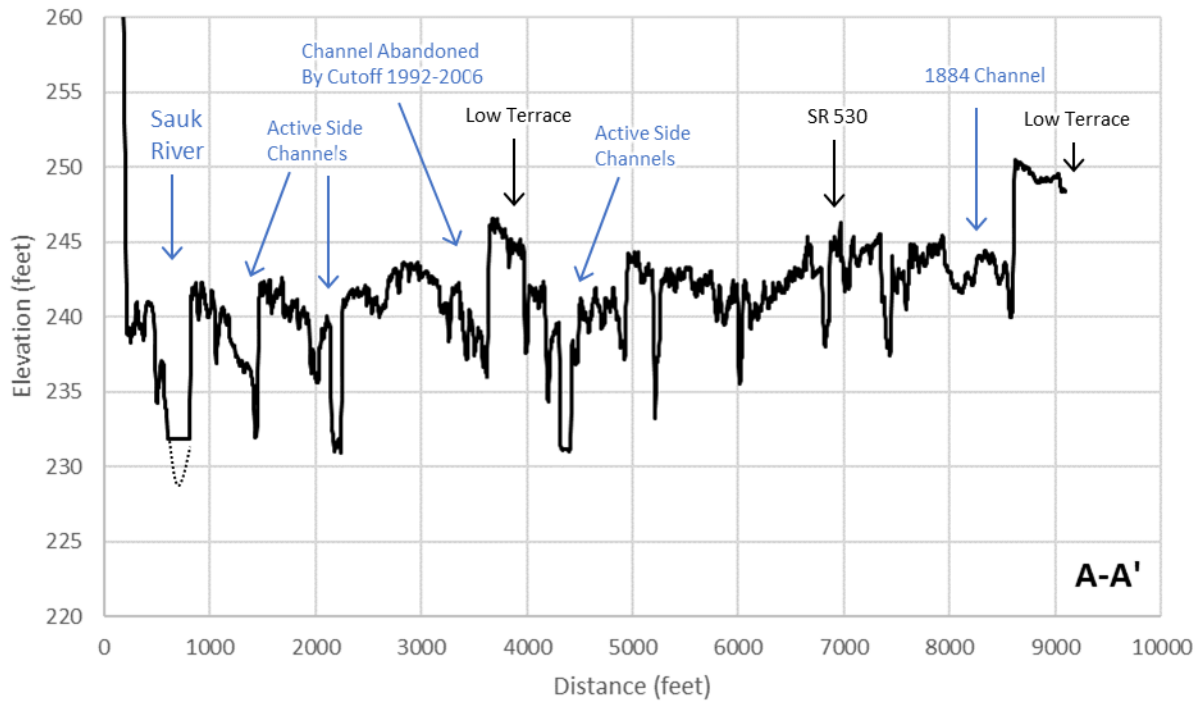
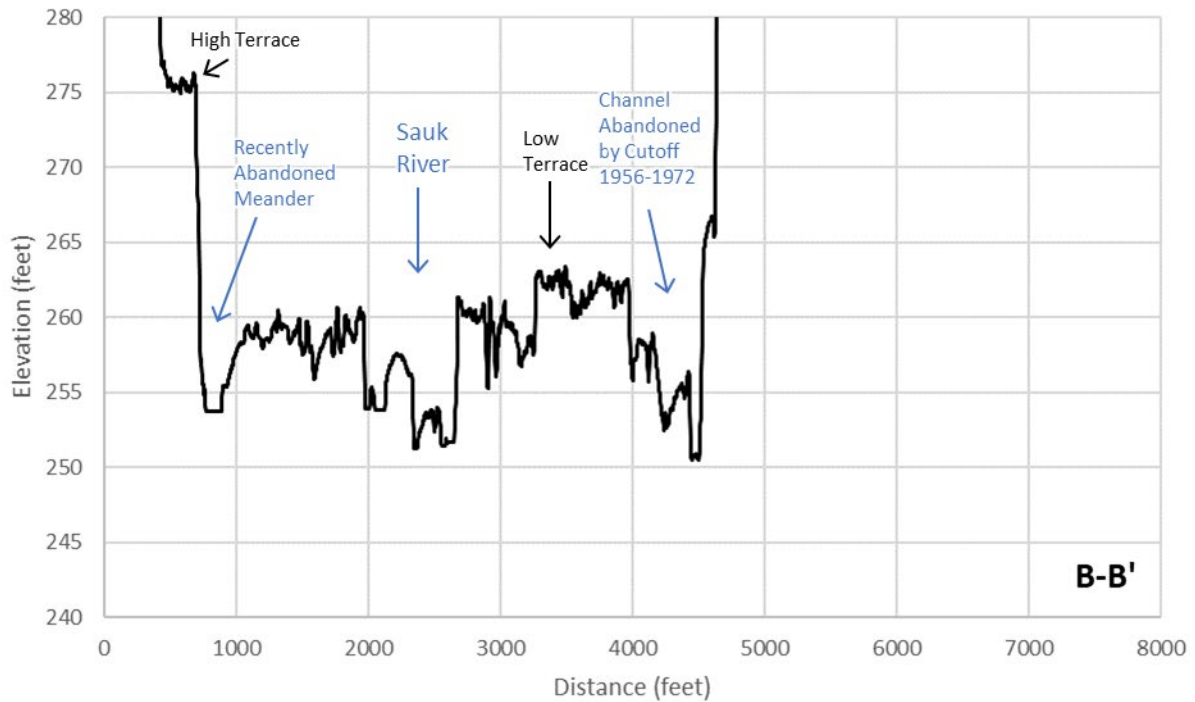
Figure 10. Cross-sections showing floodplain topography and landforms in reach SA010.

The Sauk River emerges into a broad alluvial valley downstream of RM 5 and has a broad, dynamic floodplain that forms a delta at the confluence with the Skagit River. Multiple channels meander across the floodplain surface over an area that is greater than a mile wide extending from the valley wall along the western side of the valley to a series of abandoned channel features east of the present alignment of State Route (SR) 530 and around Martin Road. Historical channels from the 1915 USGS map are overlaid with the 2016 REM in Figure 6. Historic channel features digitized by SRSC are overlaid with the 1915 channel in Figure 7. Figure 8 and Figure 9 present the 2016 lidar REM and 2019 aerial imagery of the project reach, respectively. Cross-sections A-A' and B-B' are overlaid with the REM in Figure 8 and annotated cross-sectional profiles are shown in Figure 10.

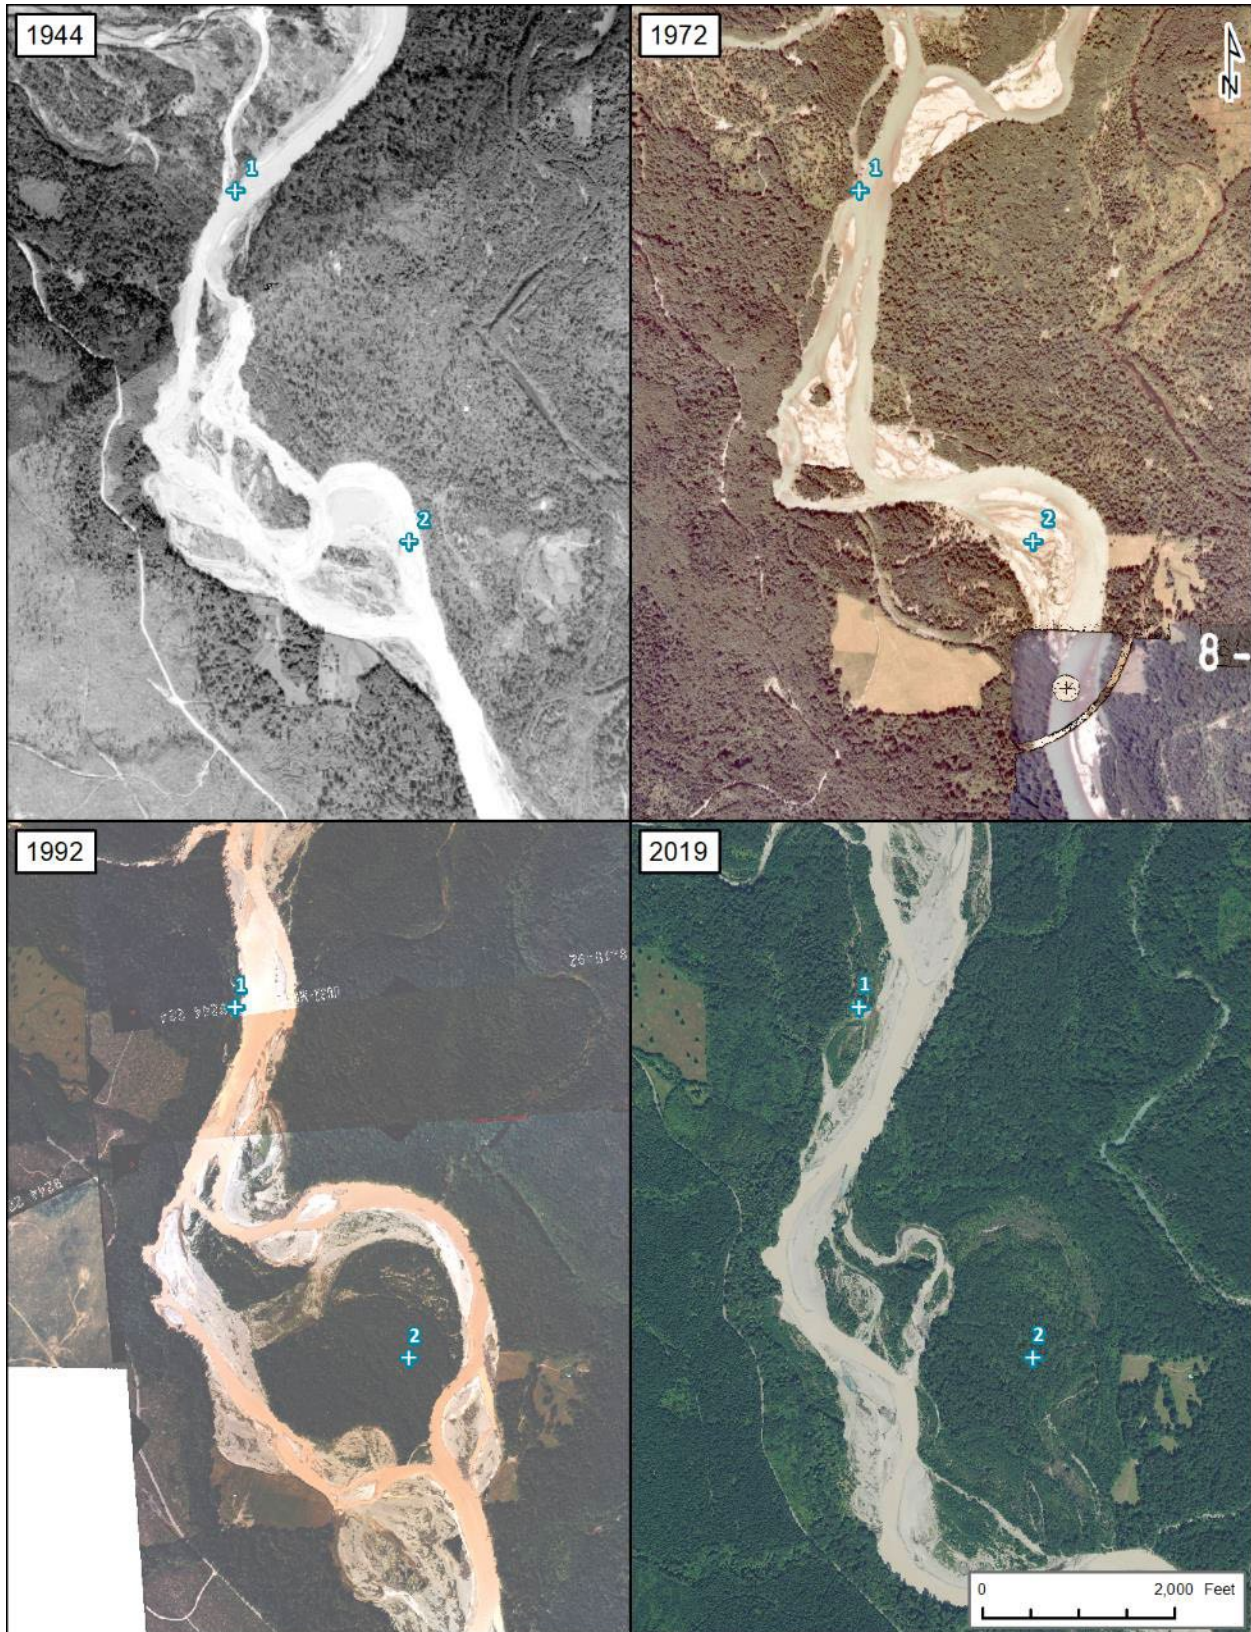
Figure 12. Time series of channel change between 1944-2019 showing abandonment of the channel feature between RM 1 and RM 2.

- Between RM 1 and RM 2, the Sauk River had a multi-threaded channel pattern in 1944 with channel migration forming a large forested island between RM 1 and RM 2 over the period 1944-1992. Further channel migration between 1992 and 2006 abandoned the longer, more sinuous channel (Figure 12).

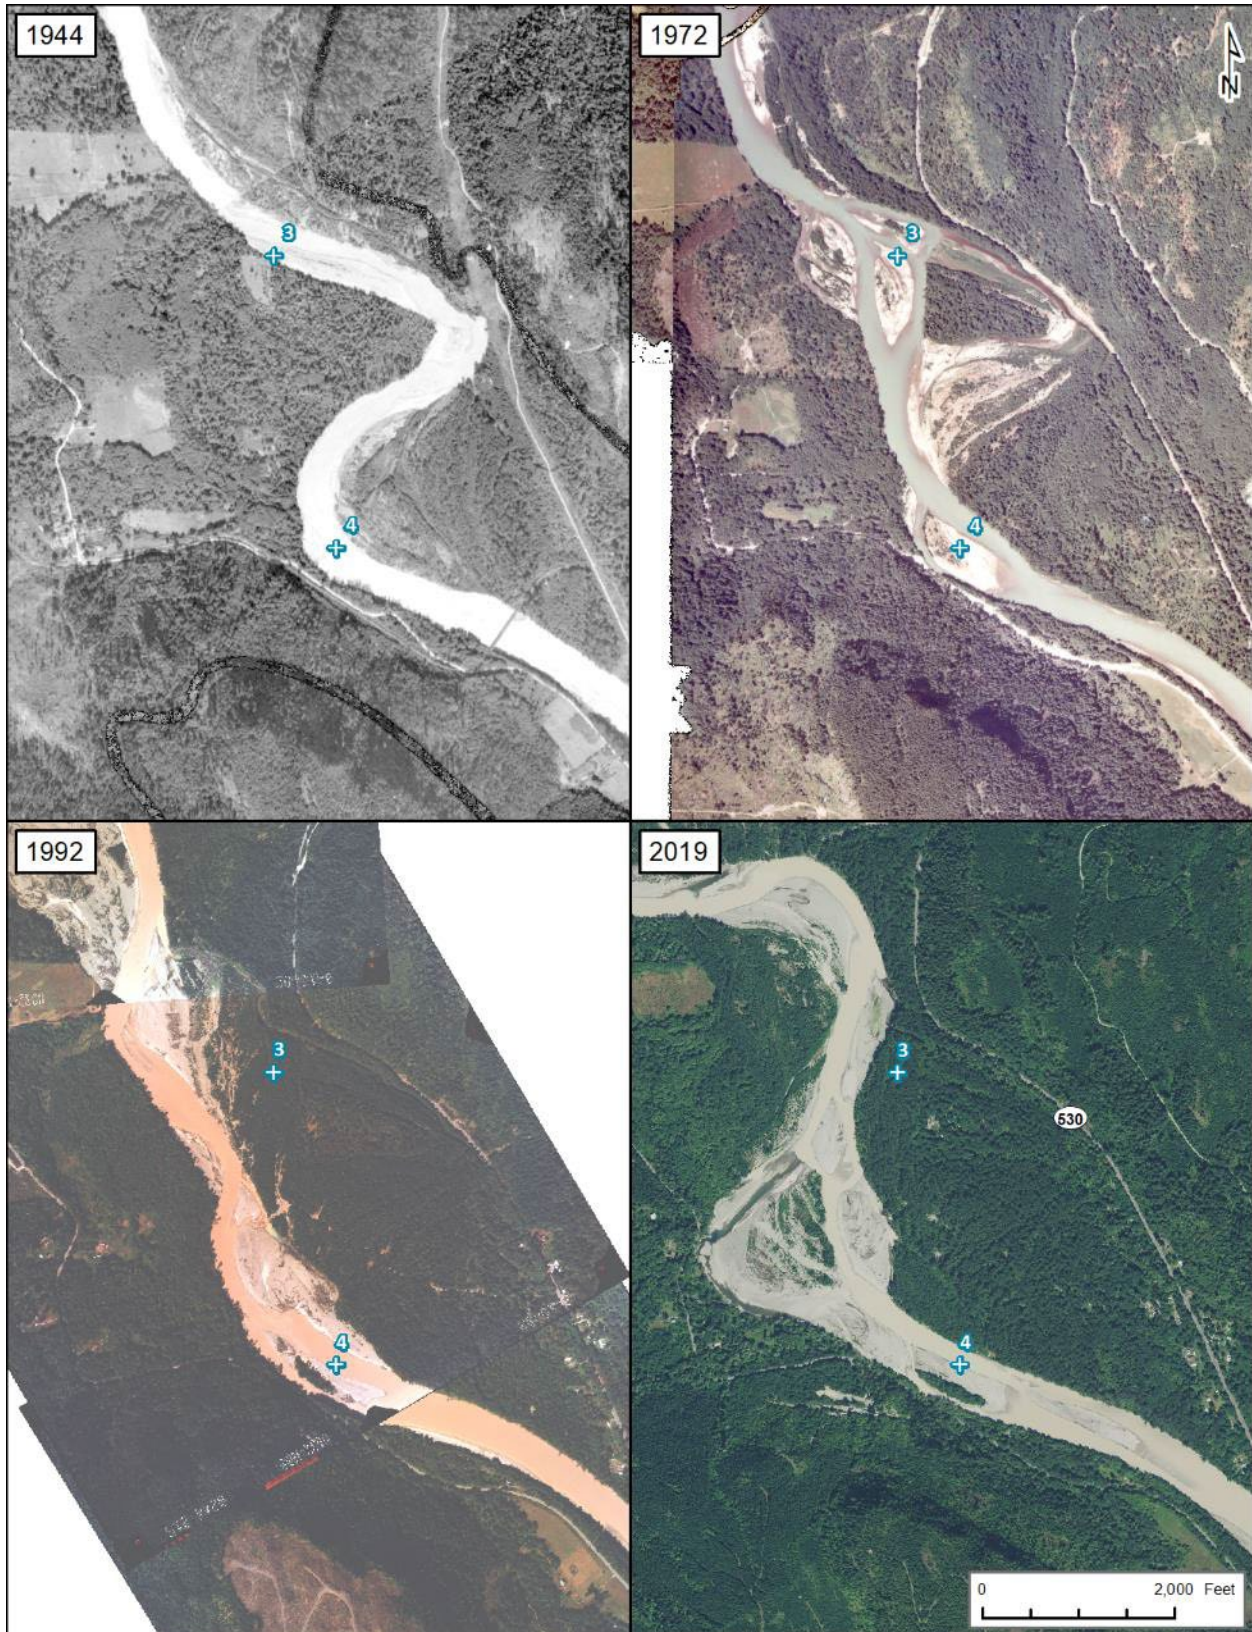
Figure 13. Time series of historical channel change 1944-2019 showing two sequences of bend cutoffs between RM 3 and RM 4.

- At the upper end of reach SA010 dynamic channel processes has resulted in two sequences of meander development and subsequent abandonment to form new floodplain surfaces. Between 1915 and 1956, the Sauk River made a high amplitude meandering pattern directing flow toward SR 530 on the east side of the valley between RM 3 and RM 4. A series of meander scrolls on the floodplain surface to the east of the Sauk River between RM 4 and 5 indicate a downstream translation of this meander prior to 1915. A cutoff formed along the inside of the bend between 1956 and 1972 and abandoned the channel on the east side of the valley near RM 3 (Figure 13). The cutoff reset the meander geometry in the reach and led to development of a new meander on the west side of the valley. The channel migrated rapidly to the west and eroded into a high terrace. Erosion undercut the steep bank damaging a segment of Concrete-Sauk Valley Road. A new cutoff then formed prior to 2015 leading to split flow condition with a developing vegetated bar in between the two channels (Figure 13).

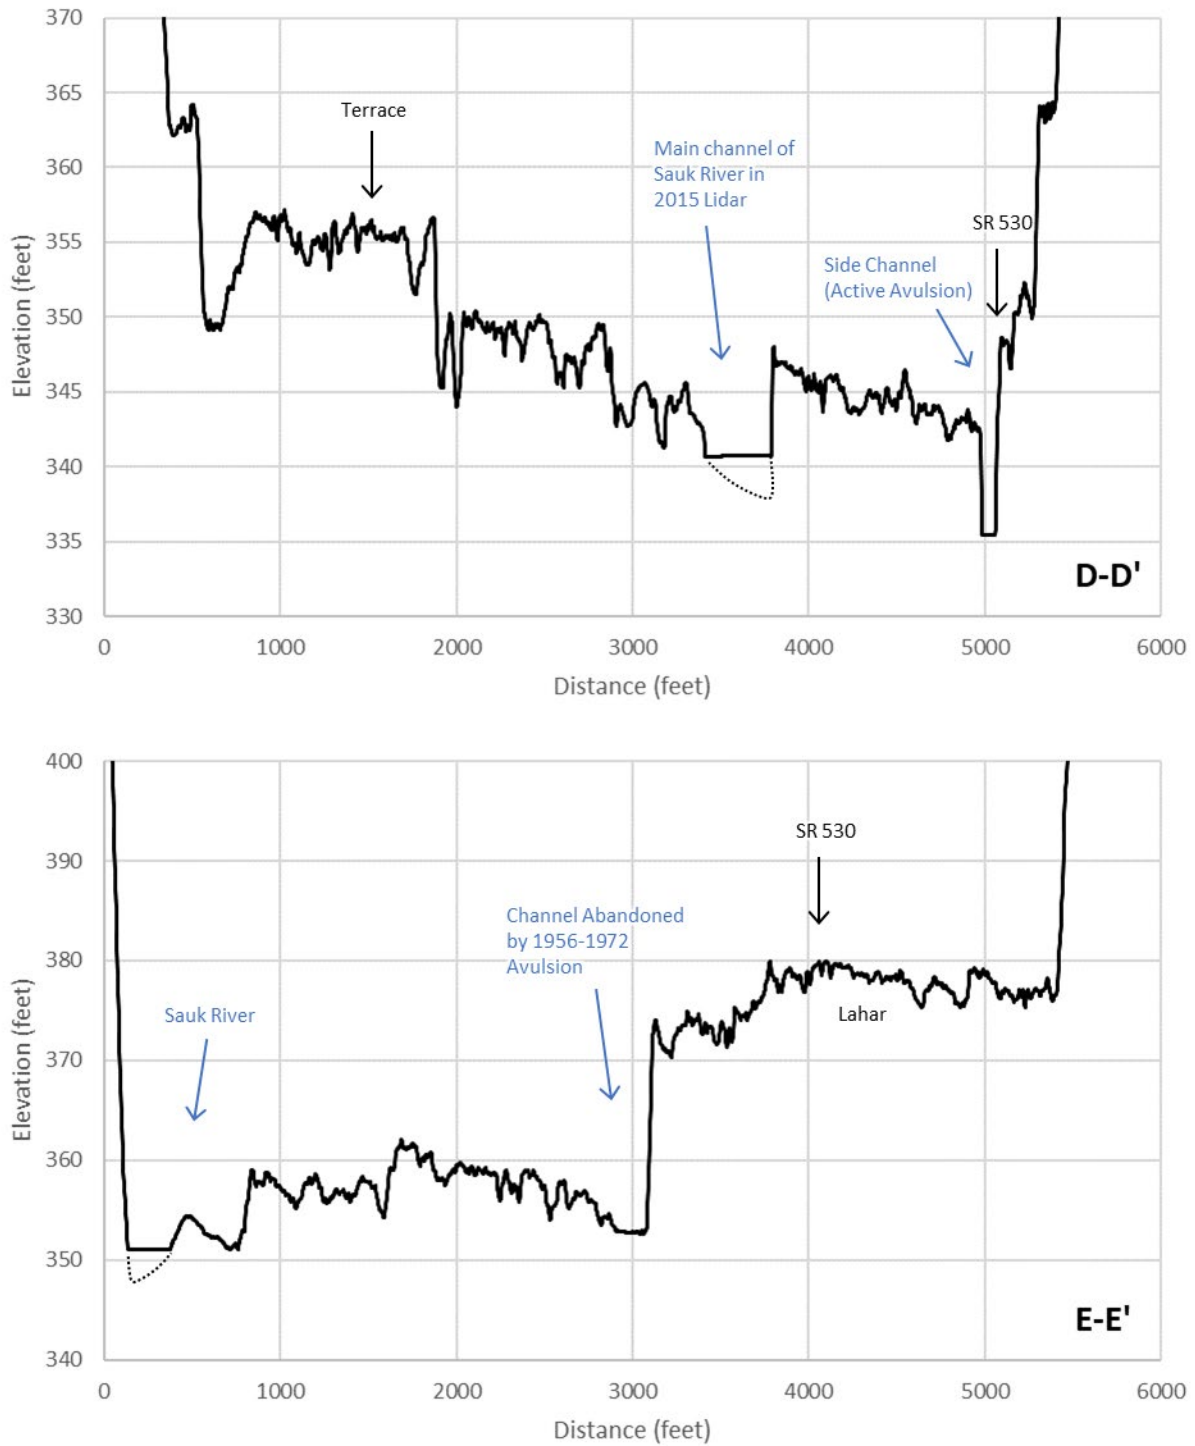
Figure 23. Cross-section profiles of floodplain topography in reach SA030.

Reach SA030 is an unconfined reach continuing upstream of the valley confinement at RM 9 to another confined valley segment at the SR 530 bridge near RM 12. The historic map from 1915 shows an alternating channel pattern with both anabranching and meandering channel segments in the reach (Figure 19). Historic channel features digitized by SRSC are overlaid with the 1915 channel in Figure 20. The 2015 REM (Figure 21) and recent aerial imagery Figure 22 show the current channel pattern and distribution of floodplain landforms. Cross-sectional profiles relating the main channel, side channels, and abandoned channel features in the floodplain are plotted below in Figure 23.

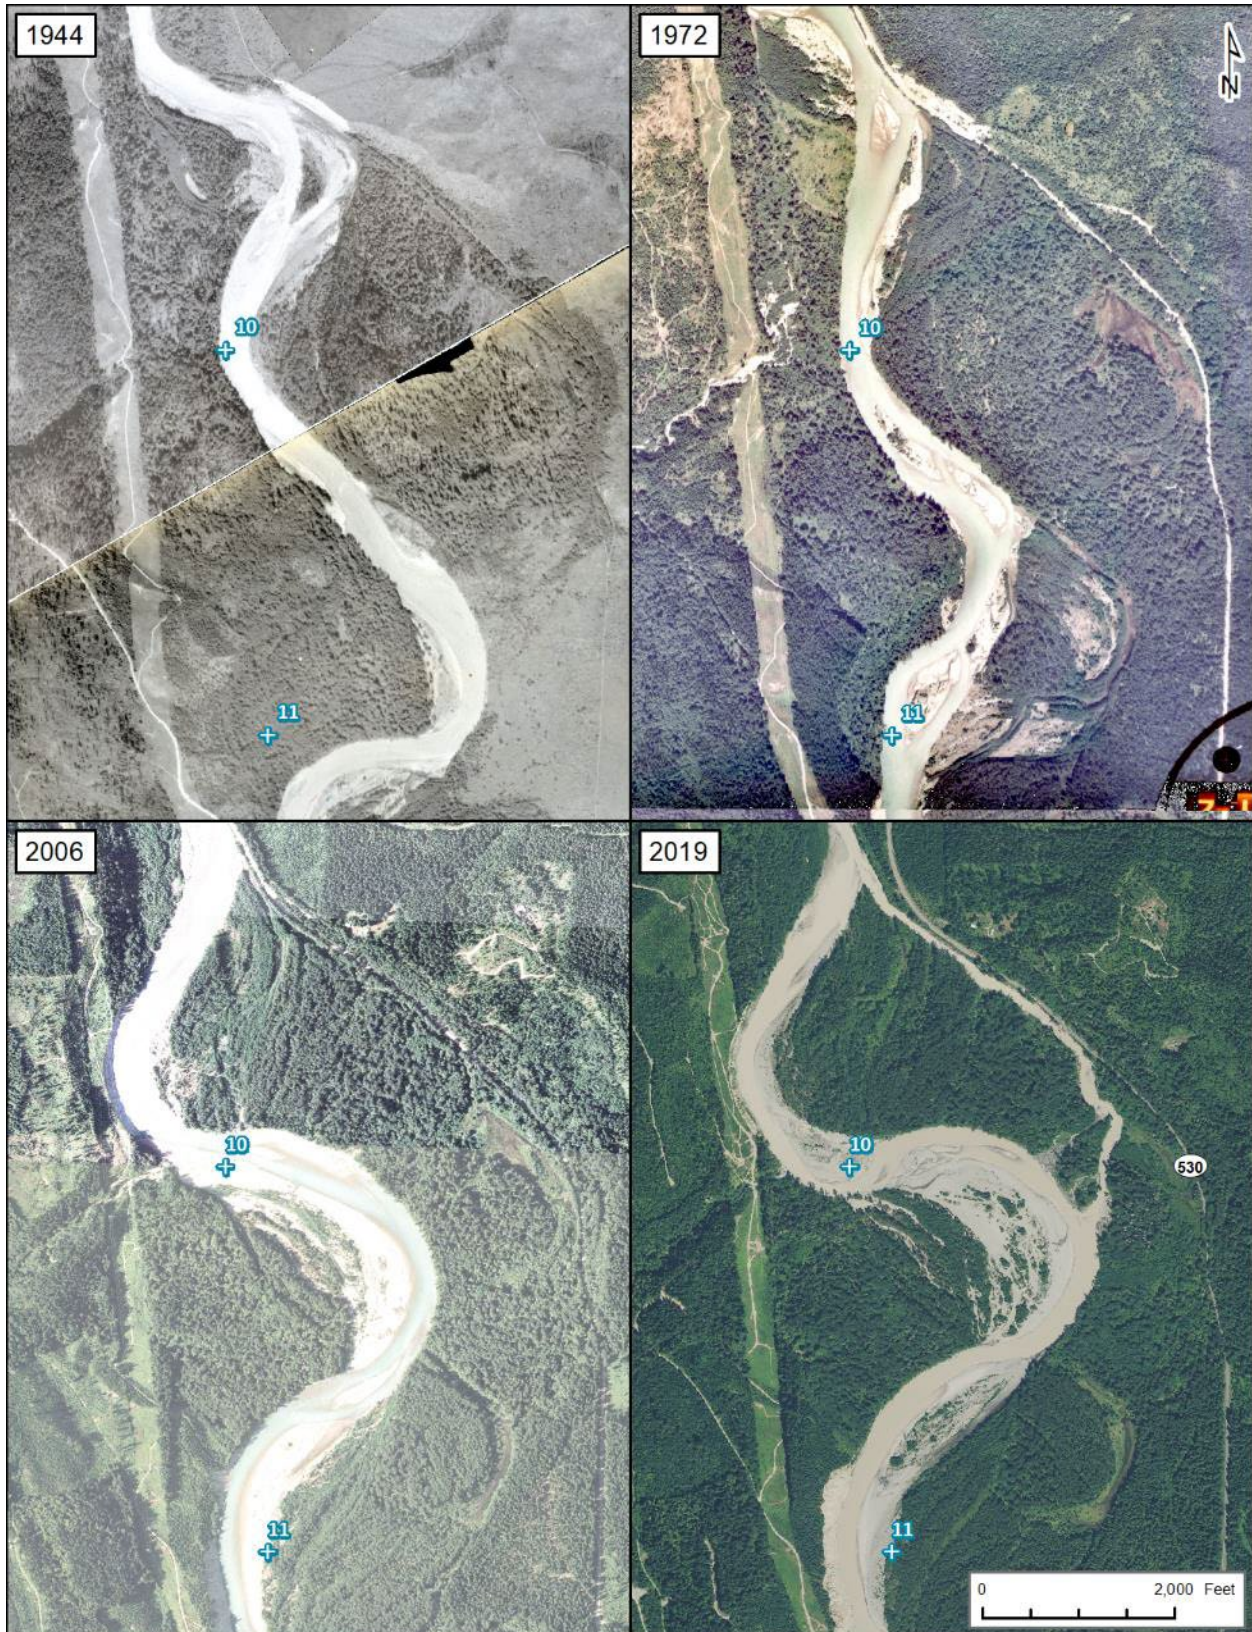
Figure 24. Time series of historical channel changes between RM 9 and RM 11.

Historical channel dynamics have been dominated by downstream translation and lateral extension of meander bends. There is existing off channel habitat within an abandoned channel near RM 11 that formed as a result of a channel avulsion that cut off the bend on the east side of the floodplain between 1956 and 1972 (Figure 24). The meanders downstream of RM 11 have been increasing in sinuosity in years since the avulsion (prior to 1972). The lateral migration rate has been greatest along the right bank upstream of RM 10 (Figure 24). There is a side channel along the edge of the floodplain that is growing in size and capturing additional flow from the mainstem as the channel migrates closer to the on the east side of the valley. This process is driving an avulsion toward the side channel that will likely cut off the meander bend on the west side of the valley between RM 9.5 and RM 10.5 and is creating an erosion hazard to SR 530 on the east side of the valley.

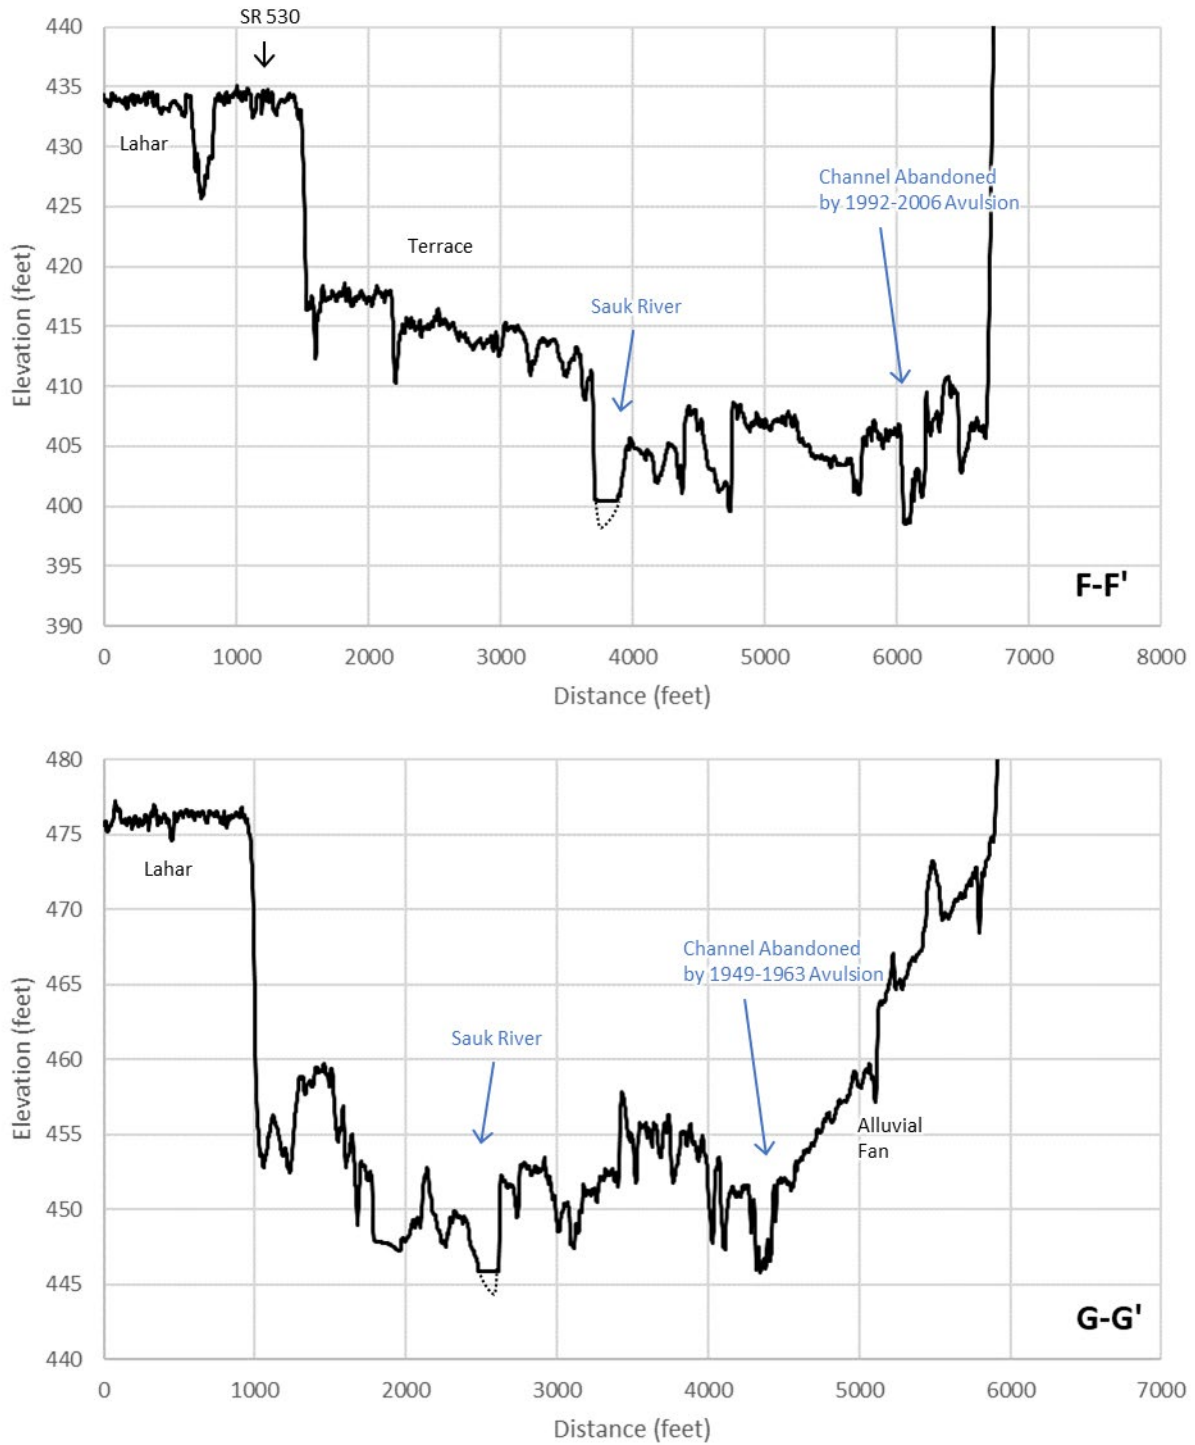
Figure 29. Cross-sectional profiles from 2015 lidar in reach SA050.

Reach SA050 extends upstream of the Suiattle River to Darrington through an unconfined valley between RM 14 and RM 21. The broad, unconfined valley is partially filled by lahar deposits that are 25 to 30 feet above the active floodplain. The floodplain widens and supports a complex network of side channels, forested islands, and braids. Figure 25 shows the historical channel location for the lower segment of this reach in 1915 and Figure 26 shows historic channel features digitized by SRSC. The floodplain topography and landforms are shown on the 2015 lidar REM (Figure 27), and 2019 aerial image (Figure 28). Cross-sectional profiles from the 2015 lidar are shown in Figure 29.

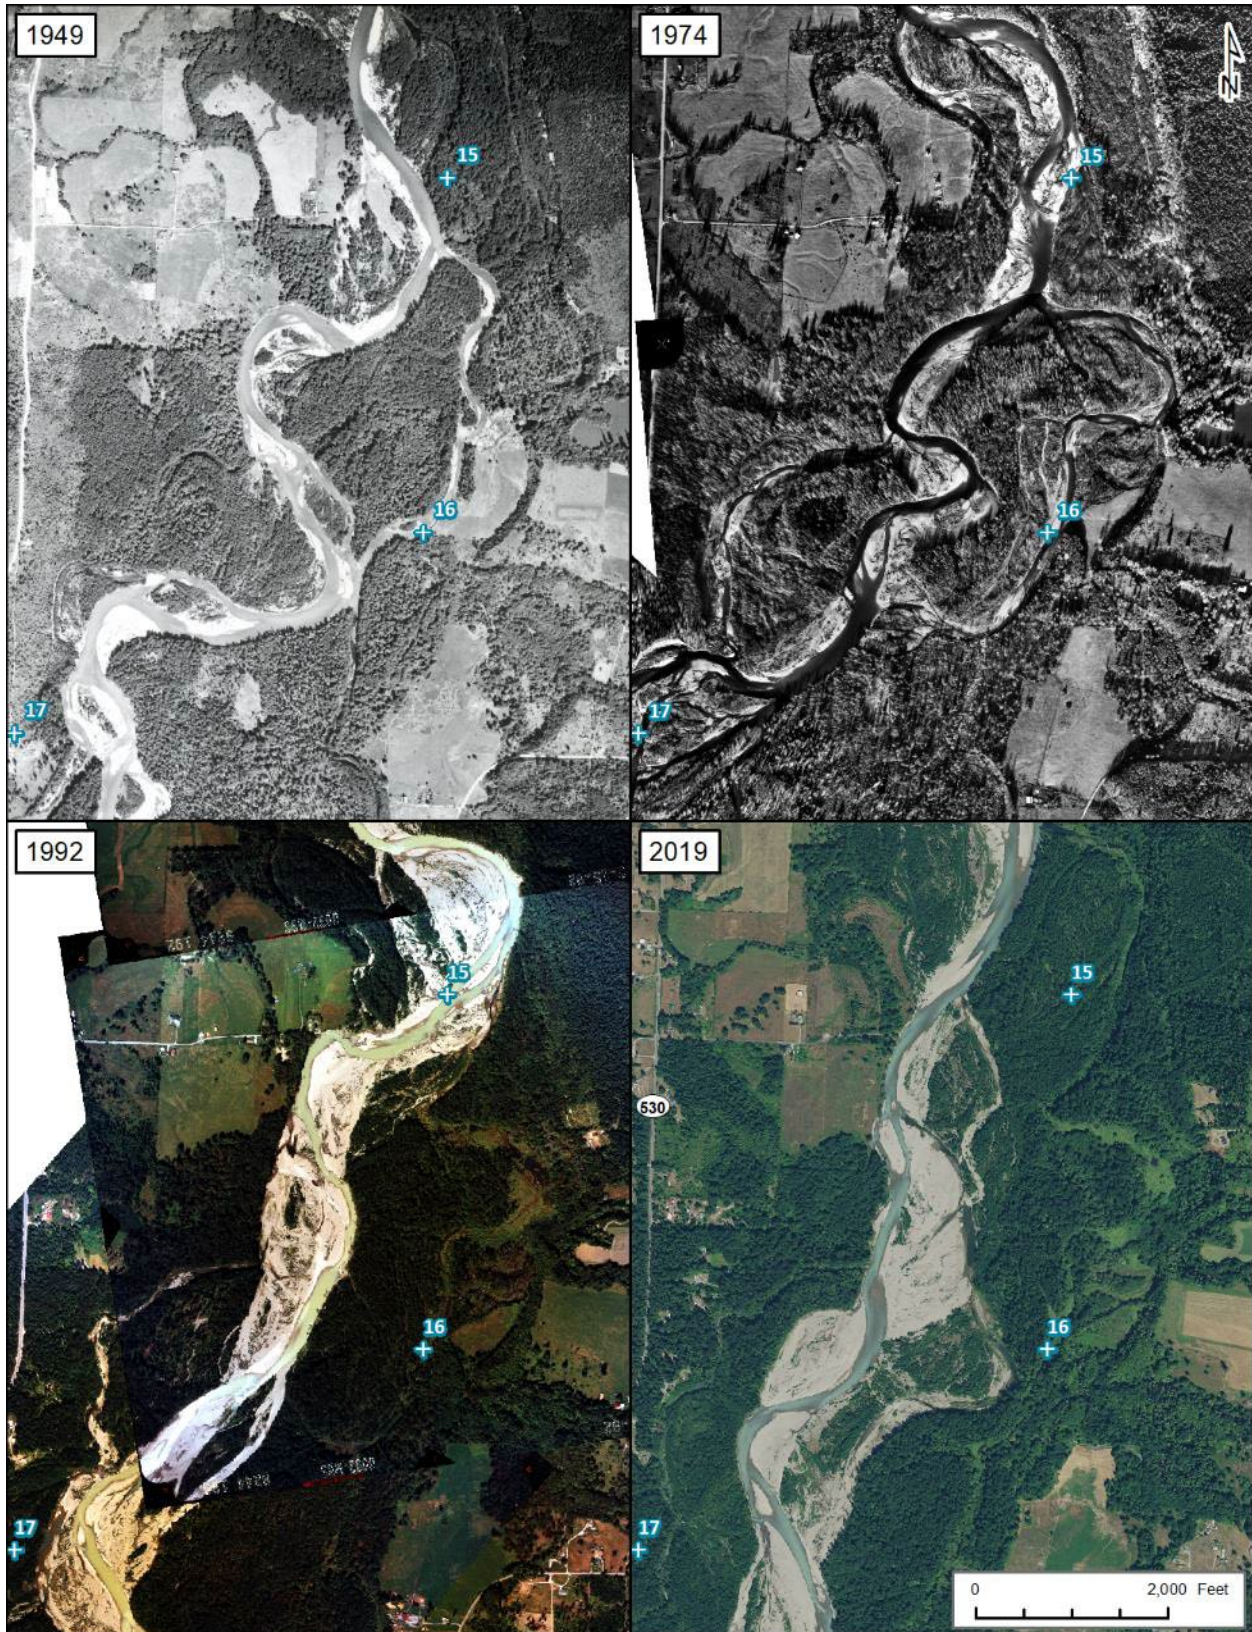
Figure 35. Time series of historical channel changes in reach SA050 between RM 15 and RM 17.

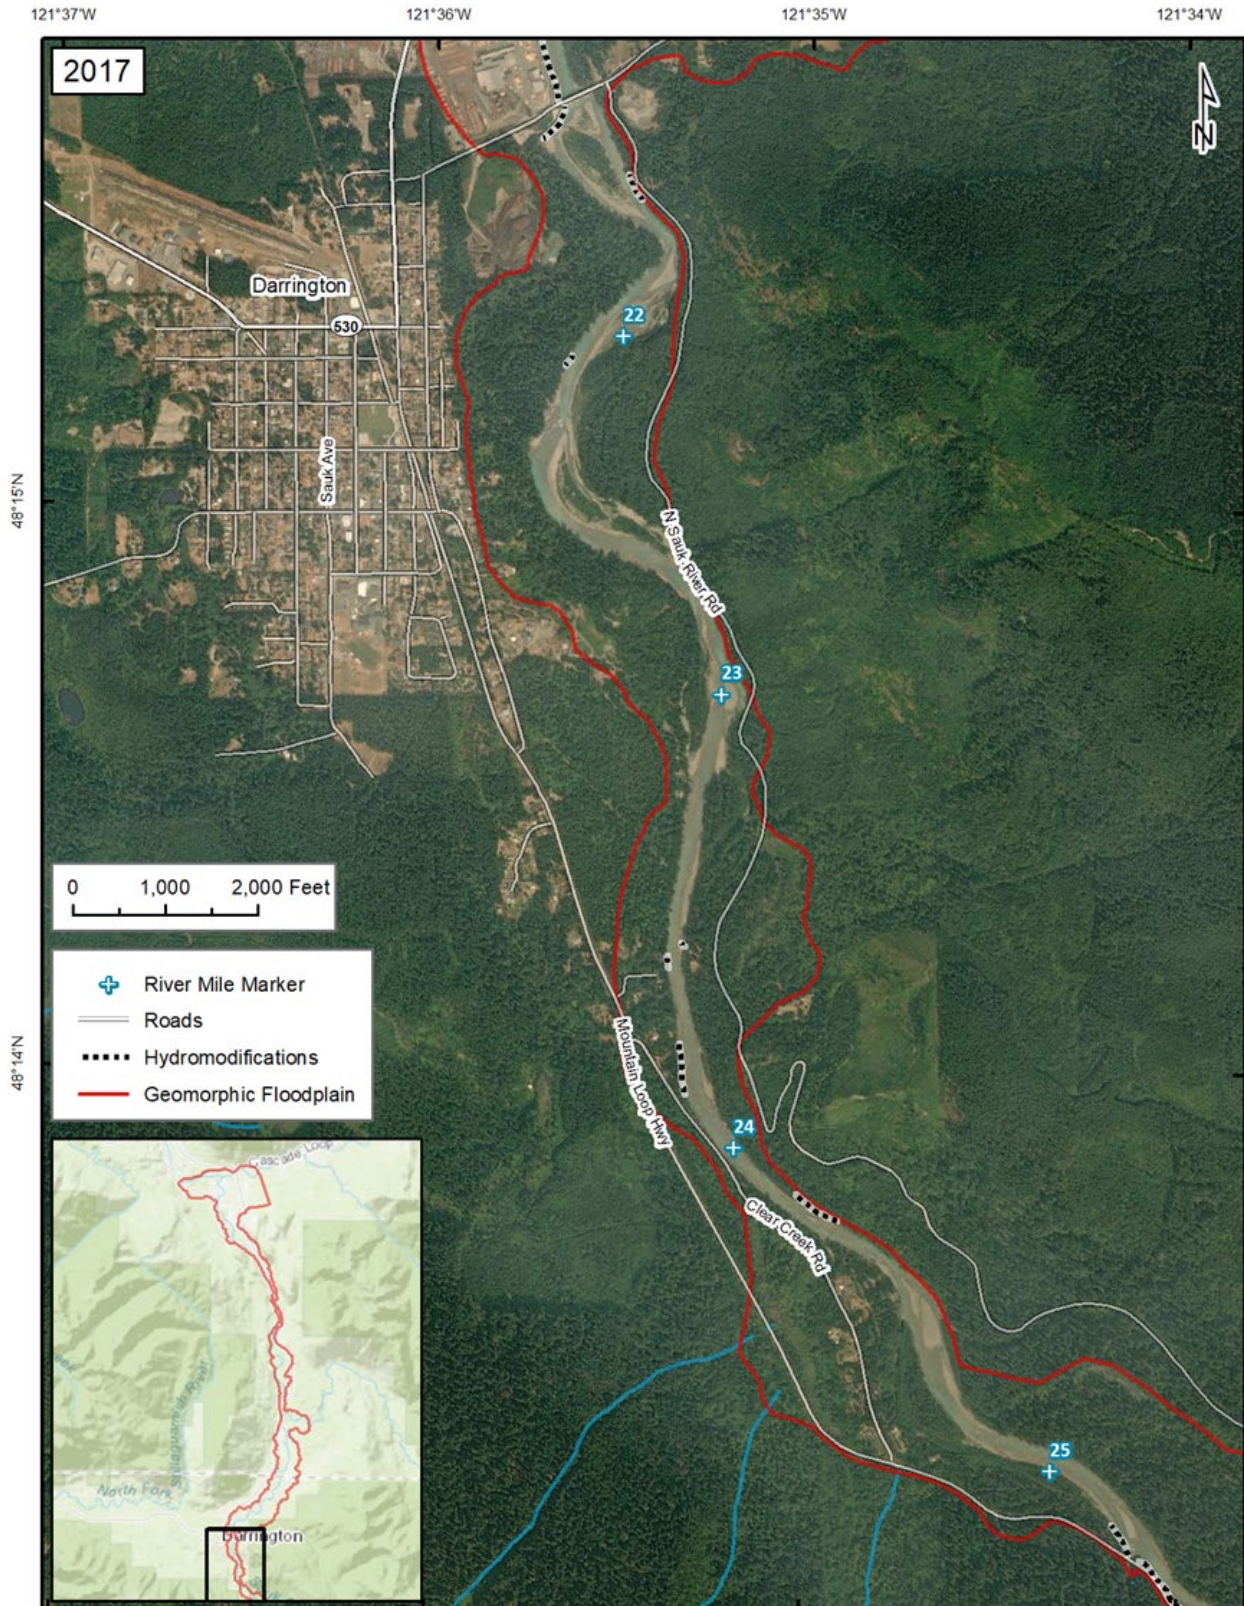
Figure 41. 2017 aerial imagery showing reach SA060.

The study evaluated a portion of reach SA060 upstream of Darrington to the tributary junction at Clear Creek near RM 25. This segment includes subreaches SA060D, SA060A, and a short segment at the downstream end of subreach SA060B. The area includes the Hampton Lumber Mill site on the left bank floodplain in addition to the Sauk Prairie Road bridge. The channel and floodplain are narrow and confined and the floodplain is the least connected of the Sauk River reaches. Below the Sauk Prairie Rd bridge nearly the entire floodplain is isolated or impaired and the river is restricted to a single thread channel. Above the bridge the river is less confined and splits around a forested island. The channel gradient begins to steepen in SA060D, which continues through to the top of the reach assessment in reach SA060B. Reach maps are included below showing the 1915 channel (Figure 38) and the historic channel alignments digitized by SRSC (Figure 39). The 2015 lidar REM highlighting the floodplain topography and landforms is shown in Figure 40 and 2017 imagery is shown in Figure 41. The channel has remained in a relatively stable alignment since the 1915 map and channel migration has been limited to moderate amount of lateral bank erosion near RM 22 and near RM 24.5.
